1. Report No. NASA CR-72899		2. Government Accession No.		3. Recipient's Catalog No.	
4. Title and Subtitle CYCLE-TESTING OF BORON-FILAMENT-WOUND TANKS				5. Report Date August 1971

6. Performing Organization Code	
7. Author(s) R. J. Alfring, E. E. Morris, and R. E. Landes				8. Performing Organization Report No.	
9. Performing Organization Name and Address Aerojet-General Corporation Structural Composites Industries Azusa, California				10. Work Unit No.

Designs were generated for 8-in.-(20.3-cm-) dia. by 13-in.-(33.0-cm-) long boron-filament-wound vessels for use as test specimens. Twenty-three vessels were fabricated and tested at ambient and cryogenic temperatures in burst tests, pressure cycling tests to failure, pressure cycling - plus burst tests, and sustained pressurization plus burst tests, with the following results:

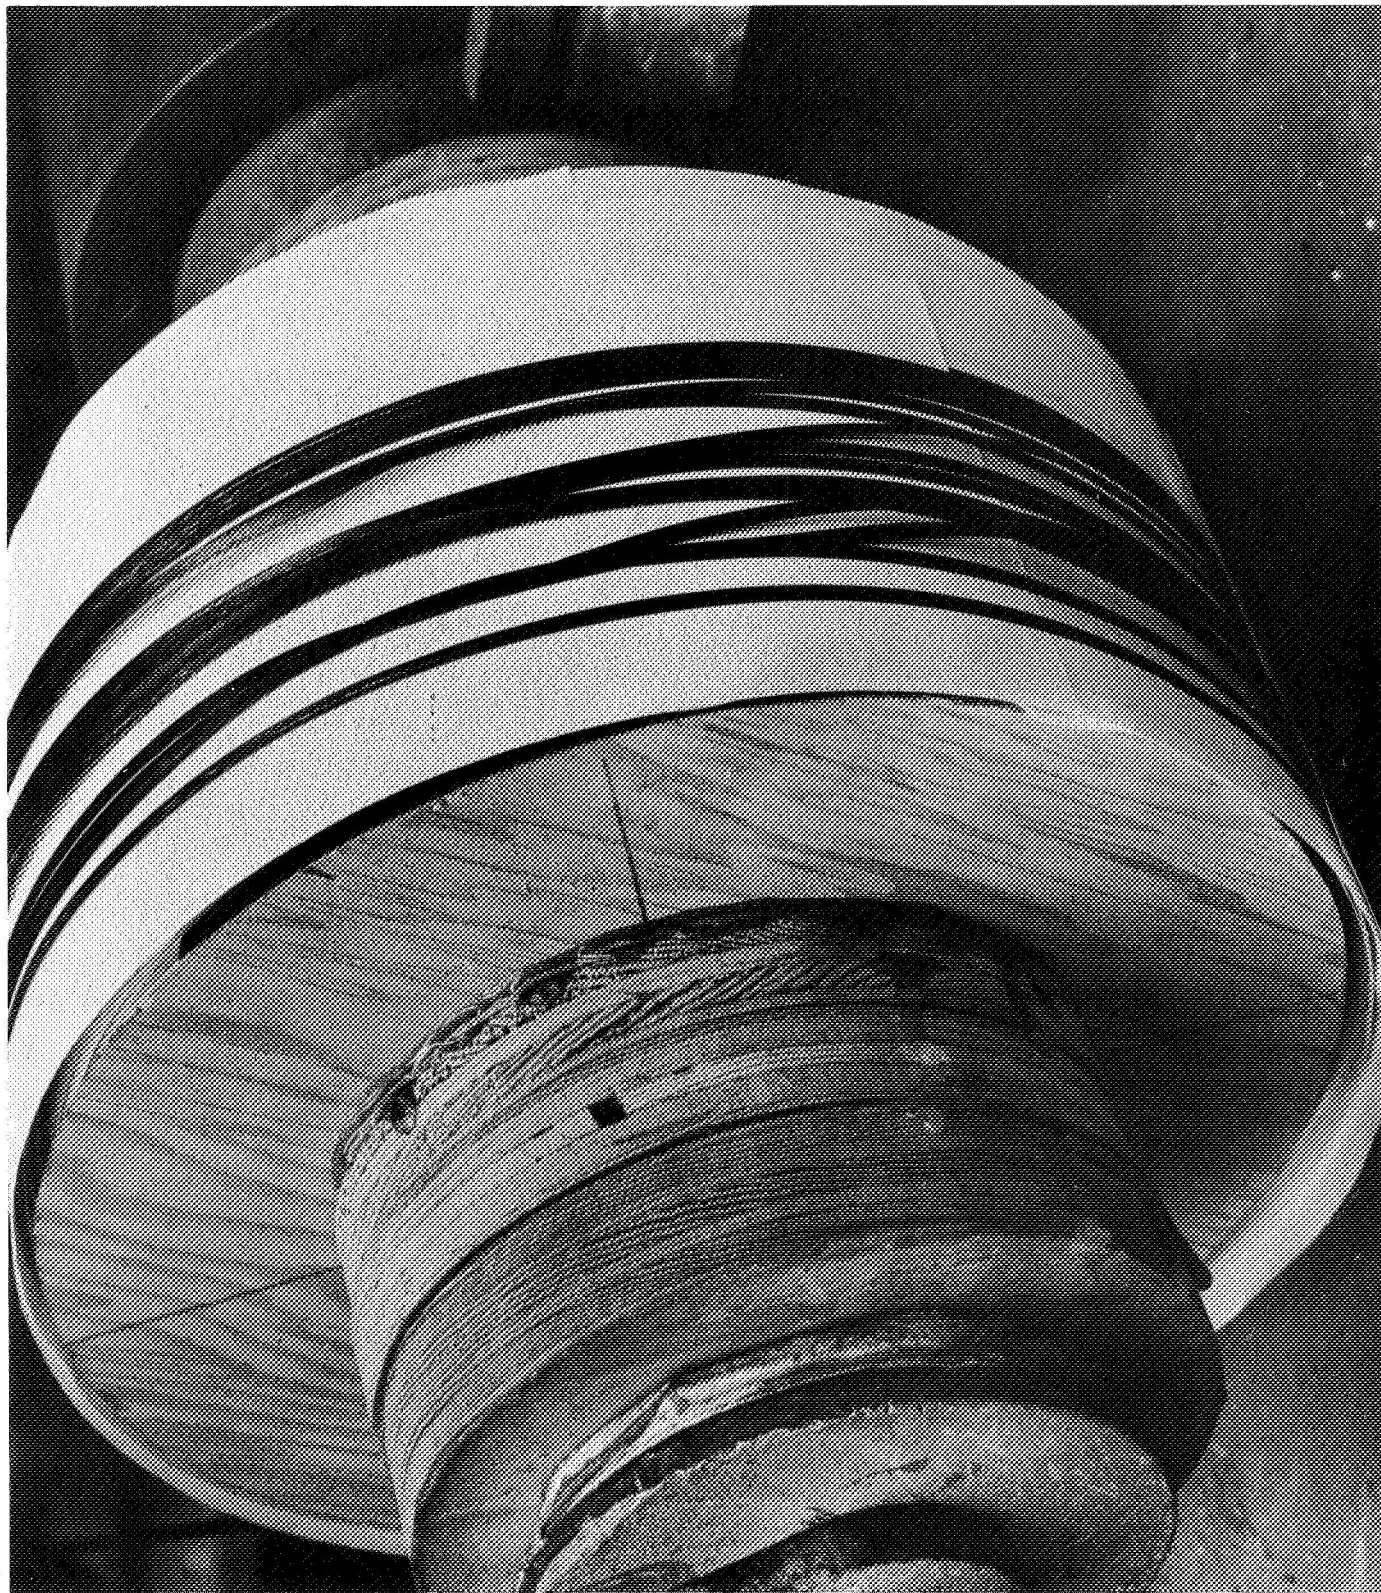
Fig. 23 Boron Prepreg Tape Spool, Showing Poor Packaging Pg. 87

During winding of the first Design B tank, BB-1, a problem of loosely spooled prepreg tape was encountered with the second lot of boron-epoxy prepreg tape used on the program, causing damage (consisting side-wise slippage on the roll, overlap of the tape, and tape necking and twisting). The damaged turns of tape were stripped from the vessel and a new roll spliced in, using the technique previously described. The second and third longitudinal revolutions looked satisfactory when initially wrapped in place, but when covered with succeeding longitudinal turns, developed a looseness in the cylindrical section. The balance of the hoop winding was applied without incident. The looseness of the cylindrical section longitudinal windings was attributed to a gathering or "ironing" effect of subsequent revolutions of winding which gathered the looseness in that particular area. It was finally concluded that the reason that this problem did not occur on the Design A vessels was due to the tension created in the windings by the hydraulic support of the metal liner (pressure was increased incrementally as additional layers were wound over the liner). The Design B vessel was wound directly on a plaster mandrel which could not expand to give the tensioning provided by the hydraulic support. Since considerable boron tape had been deposited before the winding problem was encountered and since the amount of hoop windings had been reduced to encourage hoop filament failures, the vessel was completed.

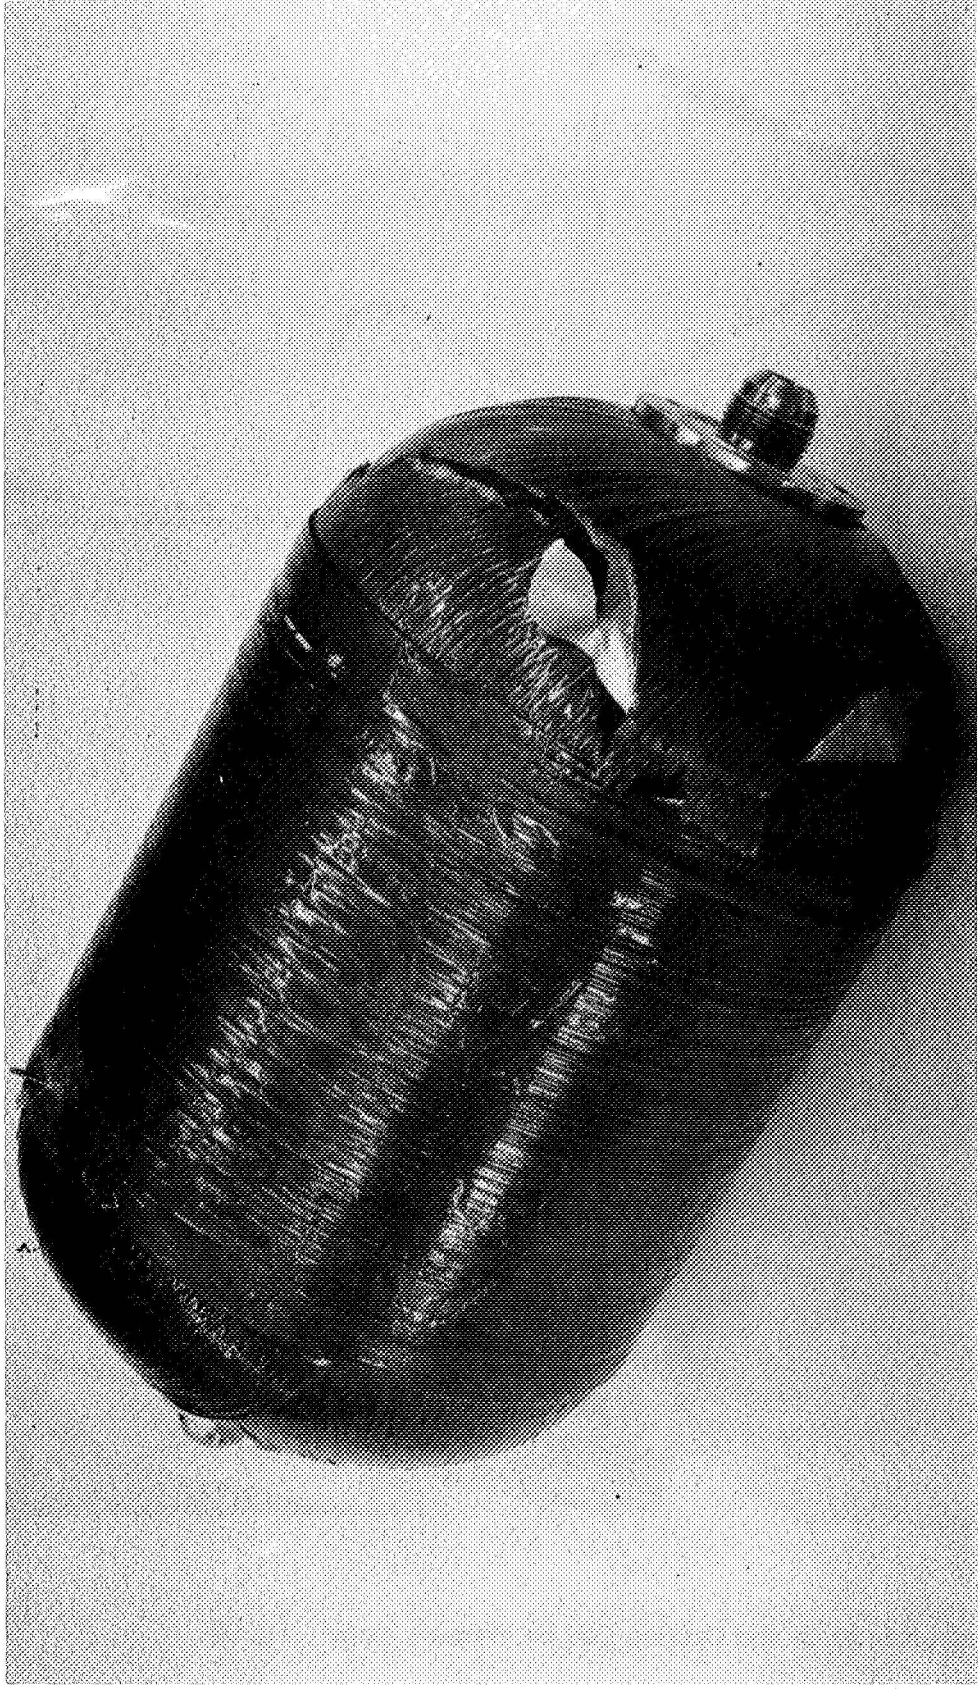
Fig. 29 Post Test Photograph of Tank B-1 Pg. 93

Tank B-1 was hydrostatically pressurized to its burst point of 1669 psig (1150 N/cm²). Failure appeared to originate in the longitudinal filaments of one head at the head-to-cylinder juncture and propagate onto the head. The failed tank is shown in Figure 29. At failure stresses were 200,000 psi (138,000 N/cm²) in the hoop filaments and 190,000 psi (131,000 N/cm²) in the longitudinal filaments. Pressure vs strain data are plotted in Figure 30.

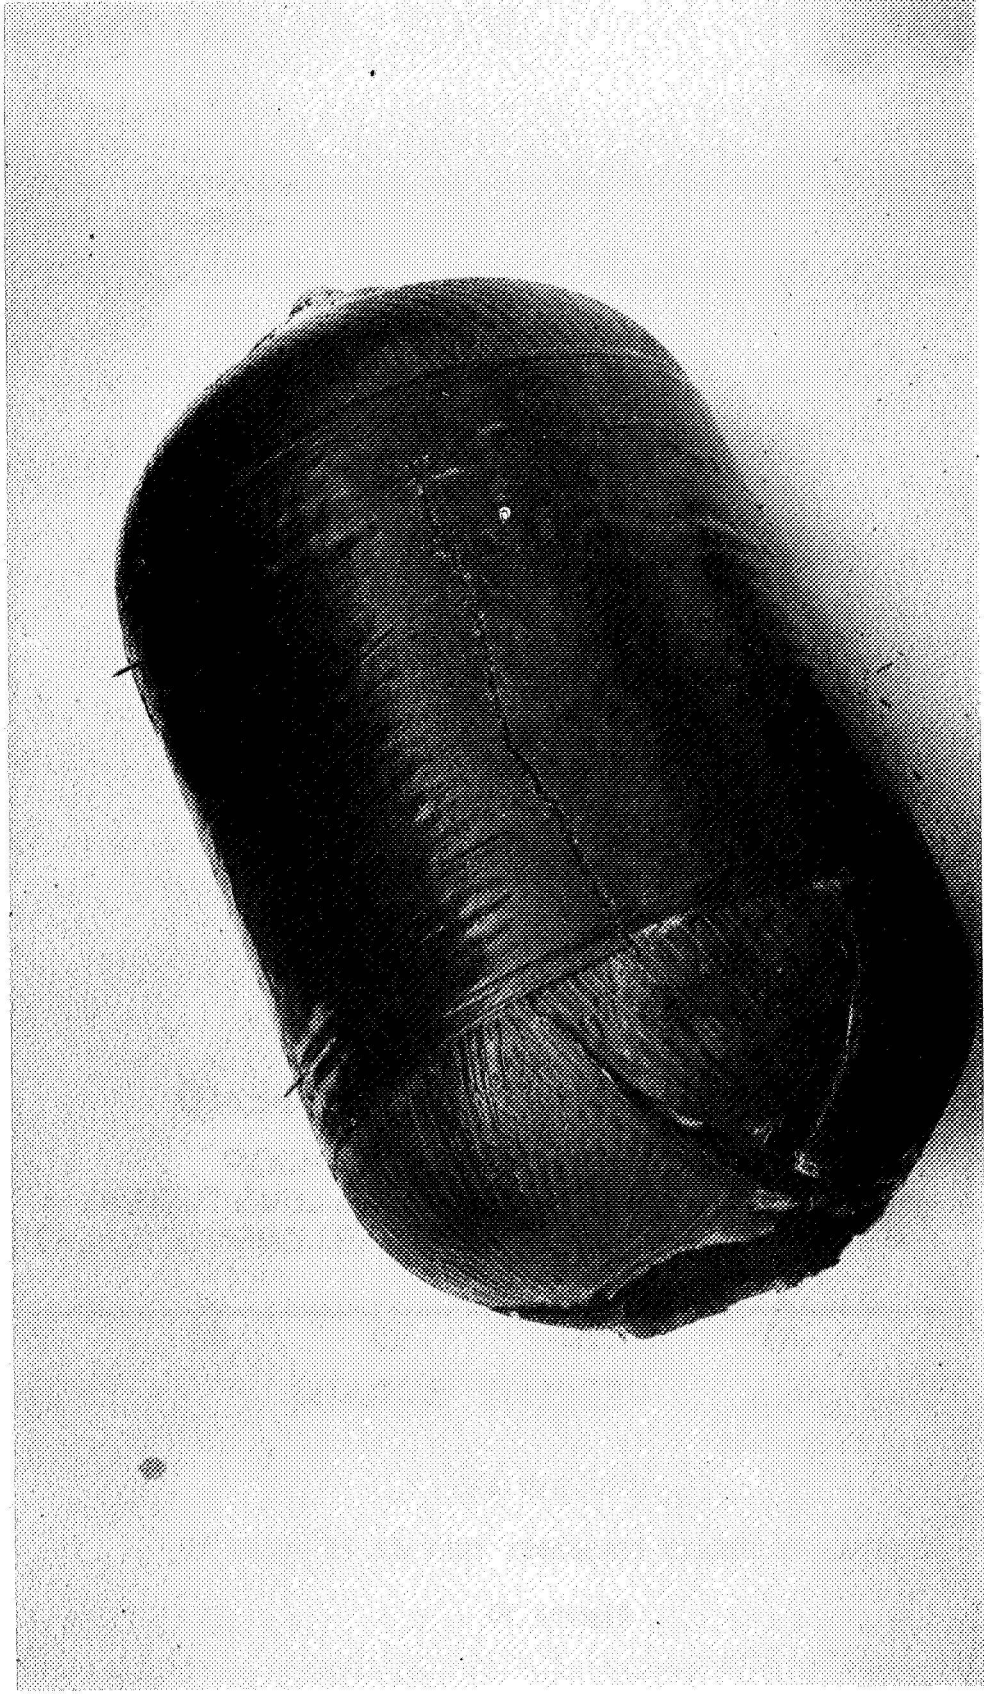
Fig. 31 Post Test Photograph of Tank B-3 Pg. 95

As noted in Section III-G, fabrication difficulties encountered with Tank B-1 were corrected in winding Tank B-3. Tank B-3 was pressurized to its burst point of 1994 psig (1375 N/cm²), a 20% improvement over B-1. Failure was in the longitudinal filaments of the head at the boss and in the cylinder section as shown in Figure 31. At failure, the stresses were 240,000 psi (165,000 N/cm²) in the hoop filaments and 230,000 psi (159,000 N/cm²) in the longitudinal. Figure 32 shows the pressure vs strain data.
